Contract #: 04-0120F4Cty: SF/ALA Rte: 80 PM: 13.2/13.9File #: 13.28**WELDING INSPECTION REPORT****Resident Engineer:**Pursell, Gary**Address:** 333 Burma Road**City:** Oakland, CA 94607**Report No:** WIR-012859**Date Inspected:** 31-Mar-2010**Project Name:** SAS Superstructure**OSM Arrival Time:** 1000**Prime Contractor:** American Bridge/Fluor Enterprises, a JV**OSM Departure Time:** 1830**Contractor:** Oregon Iron Works Clackamas, Or.**Location:** Clackamas, OR**CWI Name:** M. Gregson, J. Salazar**CWI Present:** Yes No**Inspected CWI report:** Yes No N/A**Rod Oven in Use:** Yes No N/A**Electrode to specification:** Yes No N/A**Weld Procedures Followed:** Yes No N/A**Qualified Welders:** Yes No N/A**Verified Joint Fit-up:** Yes No N/A**Approved Drawings:** Yes No N/A**Approved WPS:** Yes No N/A**Delayed / Cancelled:** Yes No N/A**Bridge No:** 34-0006**Component:** Hinge K Pipe Beams**Summary of Items Observed:**

WELDING INSPECTION REPORT

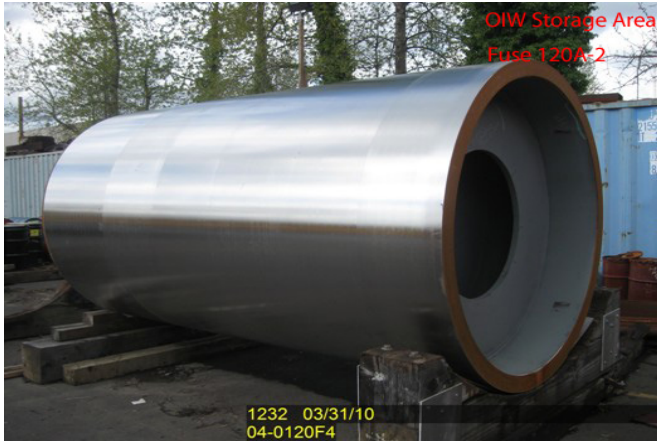
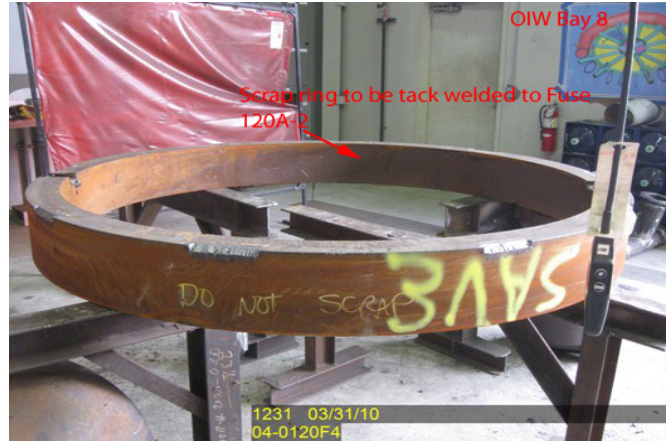
The QA Inspector witnessed WID #F17 perform grinding activities, utilizing a mechanical grinder, on the completed Stainless Steel overlay. WID #F17 explained that he was in-process of grinding high spots and various visual discrepancies that were previously marked by OIW QC Inspector Jose' Salazar. The QA Inspector spoke with QC Inspector Salazar and he explained that the grinding should be complete on this shift and OIW production personell will probably then remove this fuse 120A-8 from Bay 8 and transfer to the storage yard area. The QA Inspector noted that this Fuse will eventually be transferred to AG Machine Works, for the final machining of the overlay. QC Inspector Salazar then explained that OIW production personell will then transfer the Fuse 120A-2, from the storage yard area to Bay 8 and place on the rollers, in preparation for an additional layer of 316L stainless steel overlay. The QA Inspector noted that this Fuse had previously been at AG Machine Works and multiple weld repairs were discovered during the final machining. At the time, OIW Project Manager Bill Pender instructed AG to machine pass the required tolerance, to possibly remove most of the weld repairs. The QA Inspector noted that additional areas of repairs were still needed at this time. QC Inspector Salazar explained that the repairs will be completed, prior to the layer of 316L. The QA Inspector was then informed by QC Inspector Salazar that due to the Fuse being previously cut to length at AG machine Works, the Fuse will fit on the automatic rollers. QC Inspector Salazar explained that material will be tack welded on the end of the Fuse, that was previously cut off another Fuse, to accommodate the fit on the rollers. The QA Inspector noted that during the Electroslag Welding Process (ESW), the rollers are set to rotate to maintain the welding travel speed. QC Inspector Salazar explained that once the ESW is complete, the tacks will be cut, the ring will then be removed and the areas that were tack welded on the end of the Fuse, will be smoothed flush. QC Inspector Salazar explained that Magnetic Particle testing (MT) and a hardness check will be performed on the areas.

The QA Inspector later witnessed WID #H49 (Rick Hinckle) utilizing a hand held oxygen acetylyne torch to cut bevels on the ring, in preparation for the fit-up and FCAW tack welding of this ring to the end of the Fuse. See attached picture below.
